# Pipe length totals of PACP 7.0 inspection(s) at the States Amenities Area Existing Storm Drain

# PlanView of PACP 7.0 inspection

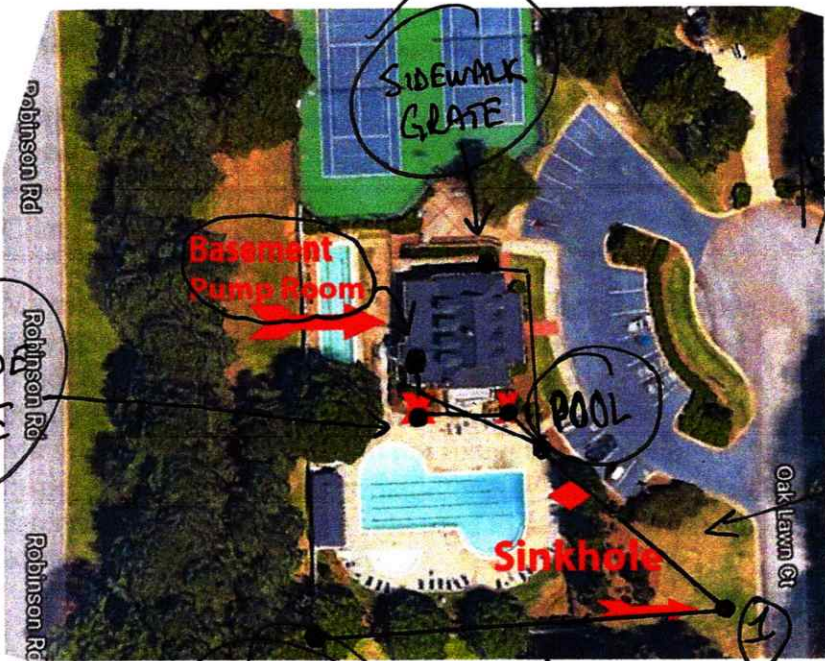
HEAVY  
DEBRIS  
IN SMALL  
PIPES FROM  
BLDG ☆

102' 12" CMP

☆ 12" CMP  
BROKEN AND ☆  
RUSTED OUT

POOLSIDE  
GRATE

ROBINSON  
RD

189' 12" CMP

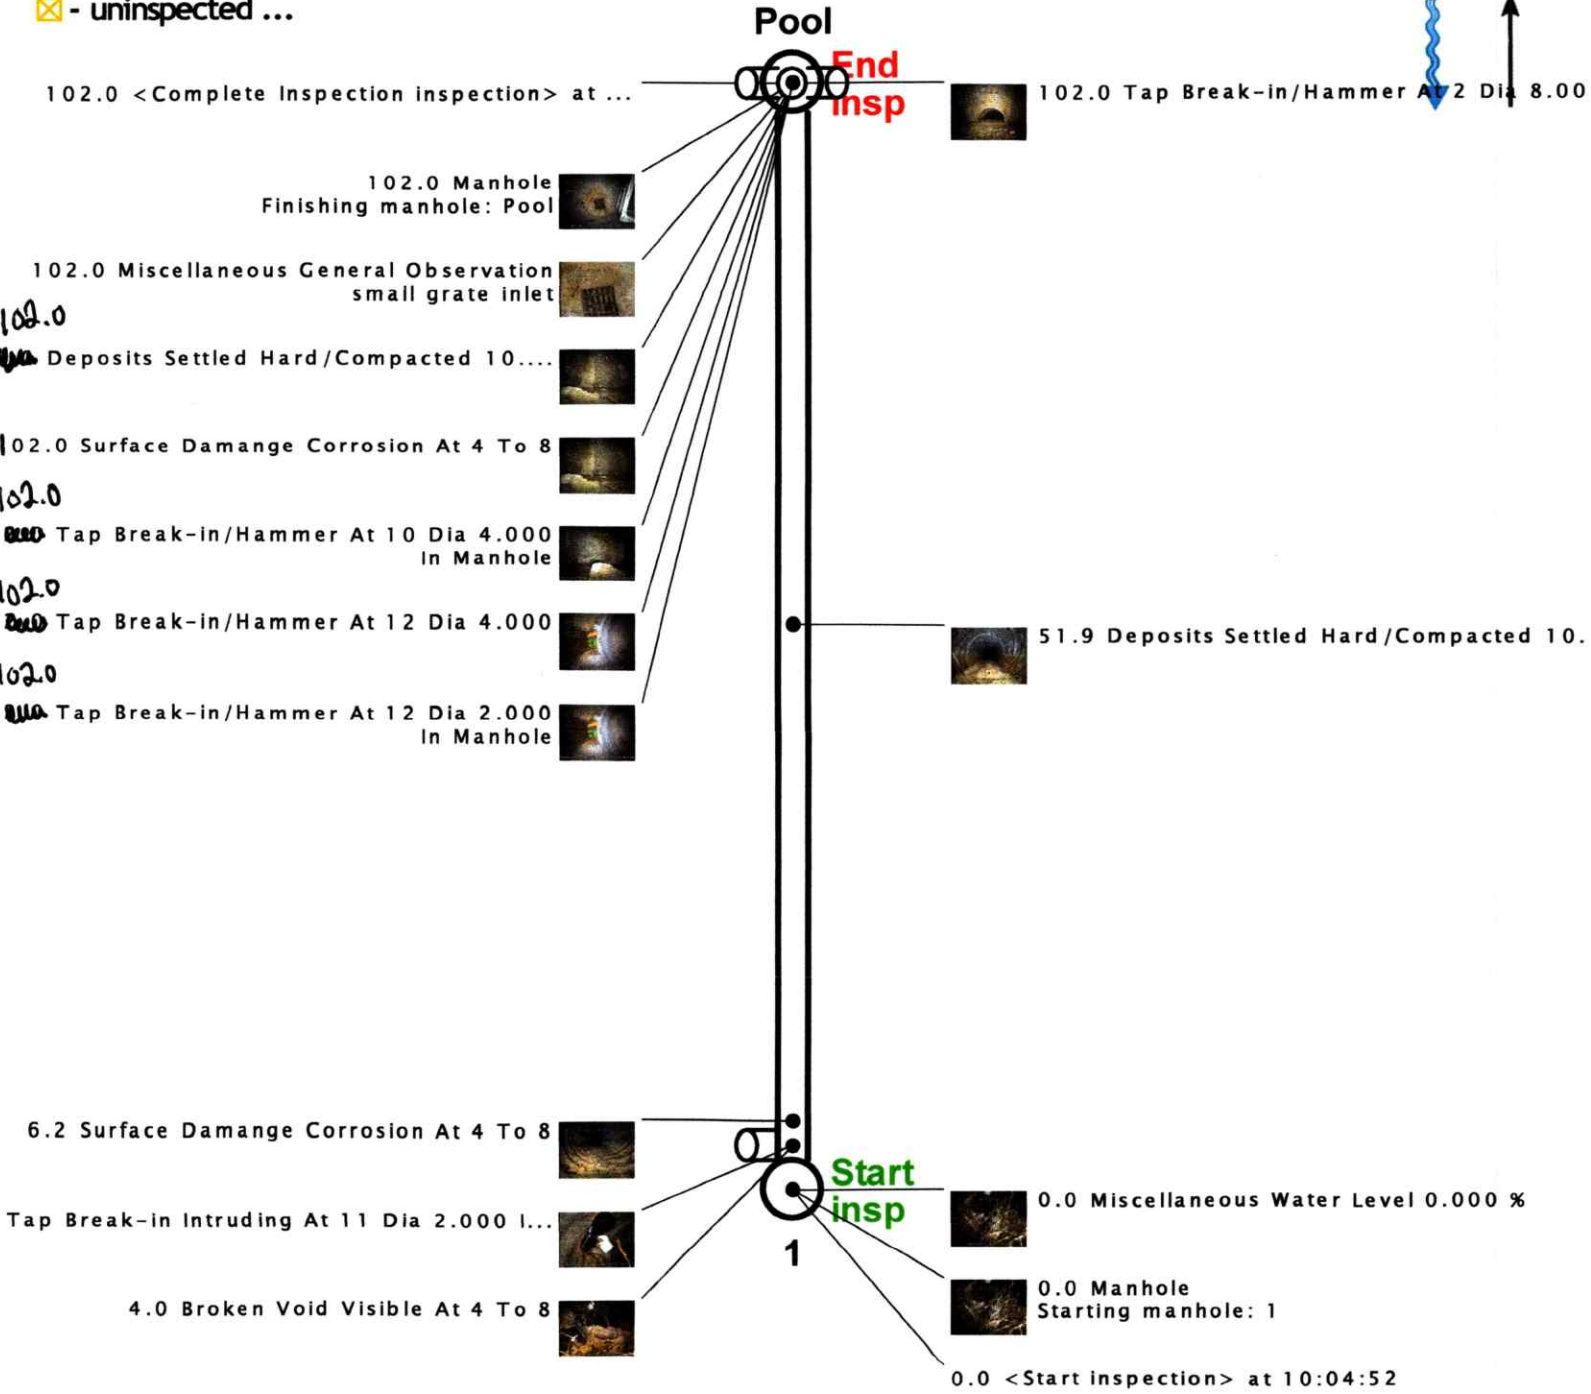
1 to Pool  
Upstream inspection

PSR TEAAESD-02			Street Oak Lawn Ct				City Peachtree City			
Date	Time	Weather	H (i)	W (i)	Shape	Material	L surv (ft)	Total l (ft)	Status	
09/13/2018	10:04:52		12		Circular	Corrugated...	102.000	102.000	Complete In...	
Video TEAAESD-02_2891_09_13_2018.mpg			<input checked="" type="checkbox"/>		Additional info Existing Storm Drain		Purpose Pre-Rehabilitation Su...		Sheet 1

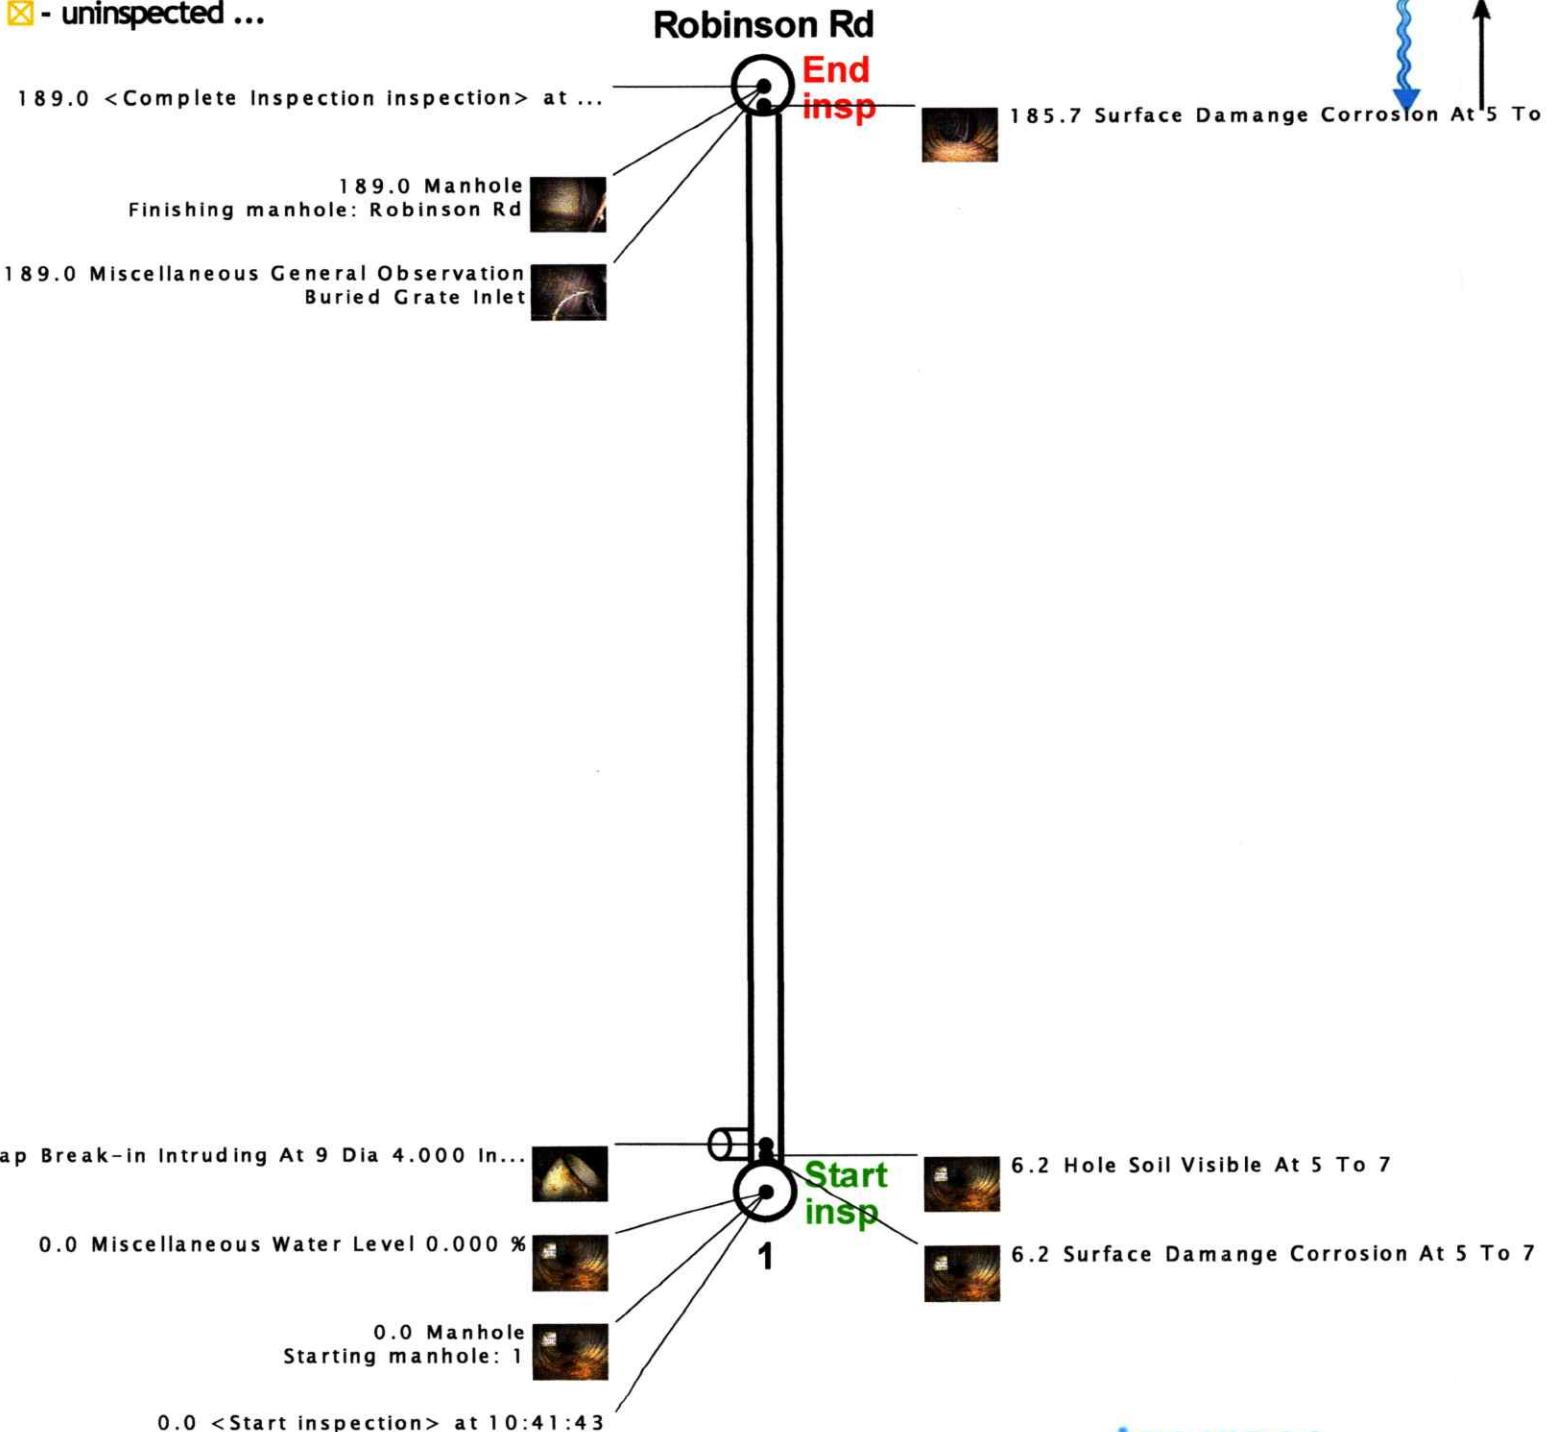
1 to Robinson Rd  
Upstream inspection

PSR TEAAESD-01			Street Oak Lawn Ct				City Peachtree City			
Date	Time	Weather	H (i)	W (i)	Shape	Material	L surv (ft)	Total l (ft)	Status	
09/13/2018	10:41:43		12		Circular	Corrugated...	189.000	189.000	Complete In...	
Video			Additional info			Purpose		Sheet		
TEAAESD-01_2892_09_13_2018.mpg			<input checked="" type="checkbox"/>			Existing Storm Drain		Pre-Rehabilitation Su...		1
